GIANT FOREST  
**SEQUOIA**

**A Historical and Architectural Study of  
Three Rustic Structures at Giant Forest in Sequoia National Park  
The Market, District Ranger's Residence, and Comfort Station**

**HISTORIC STRUCTURES REPORT  
SEQUOIA NATIONAL PARK**

Approved  
December 7, 1988

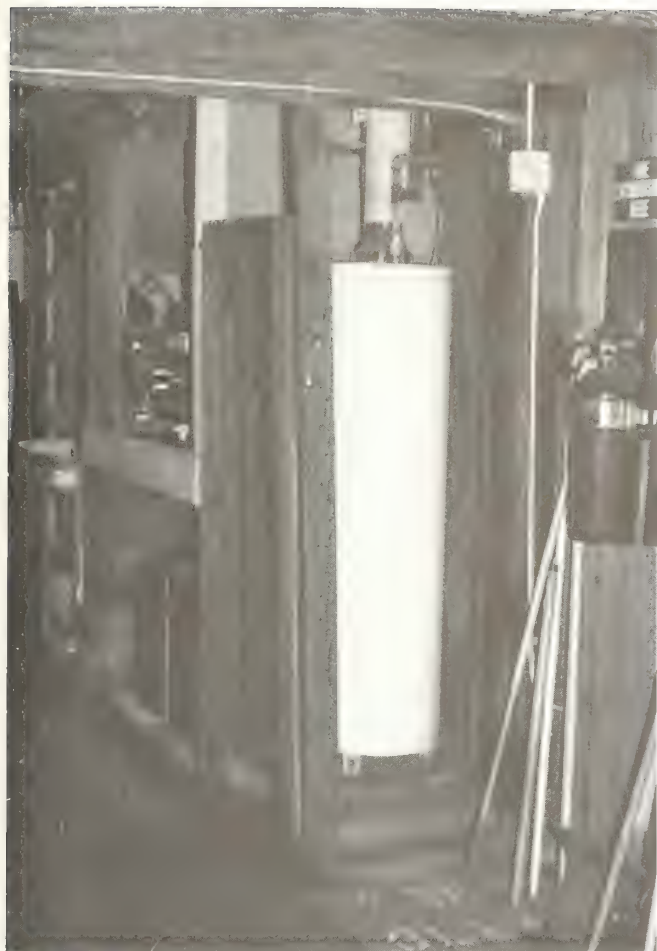
KGA-30-879, 36,000 BTUH (figure D-4). Currently it is the sole source of hot water in the market building and serves one employee sink in the market section (figure D-1), and one employee sink and a triple bar sink in the bar section of the building. It is adequate for present uses but should be replaced to serve intended loads at the time of the building rehabilitation. An electric model would likely replace this unit assuming the propane is removed. The water pipe is partly covered by old style insulation, which is in bad shape (figure C-6). A sample was collected and sent to a lab for detection of asbestos. Test results report is included in Appendix F.

Figure D-4. Market--Water Heater (5/86).

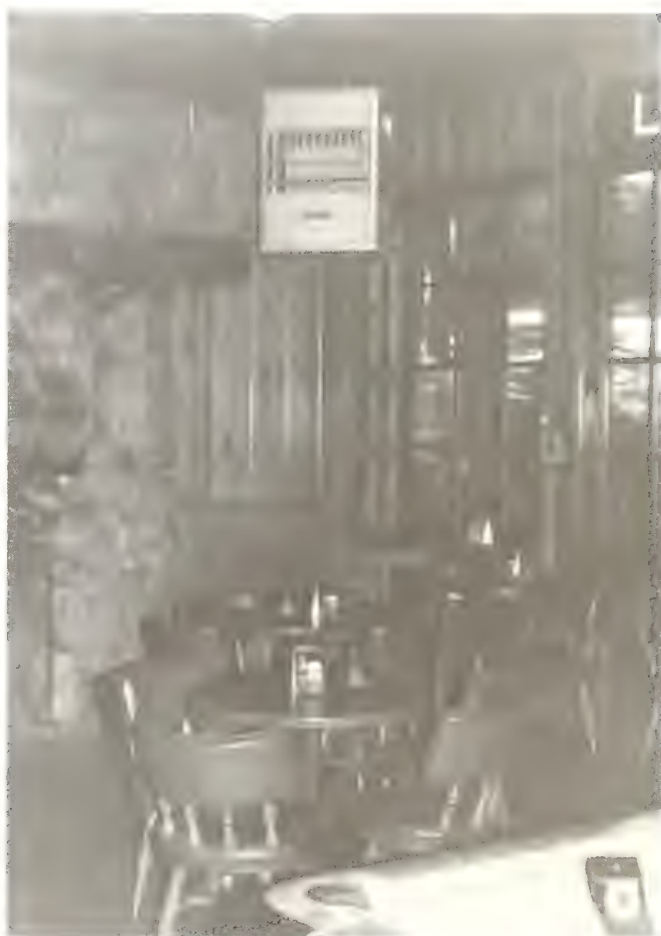
Figure D-5. Market--Unit Heater (5/86).

The market building is heated by three ceiling mounted propane-fired unit heaters. The plumbing system consists of three sinks and condensate waste from various coolers. The systems are adequate for current use, but should be replaced when the buildings undergo the rehabilitation planned.

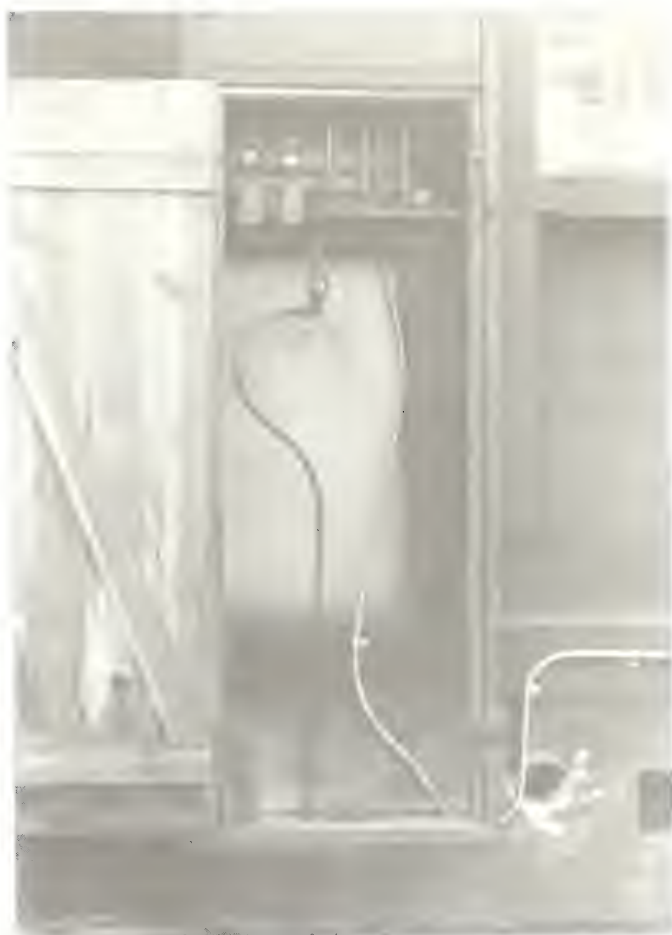
Figure D-6. Market--Propane Distribution Vault (5/86).

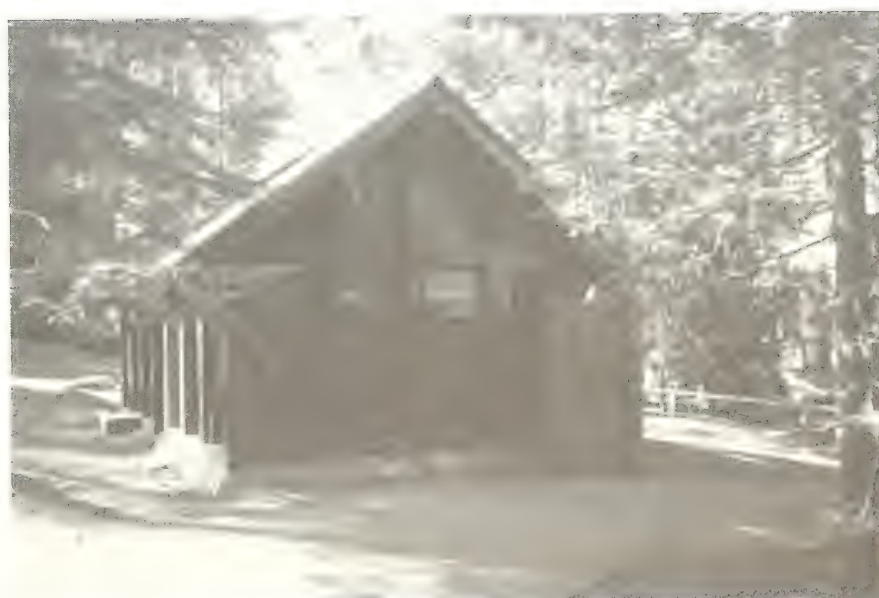
Figure D-7. Comfort Station--Auxilliary Vent Line Under Eaves (5/86).

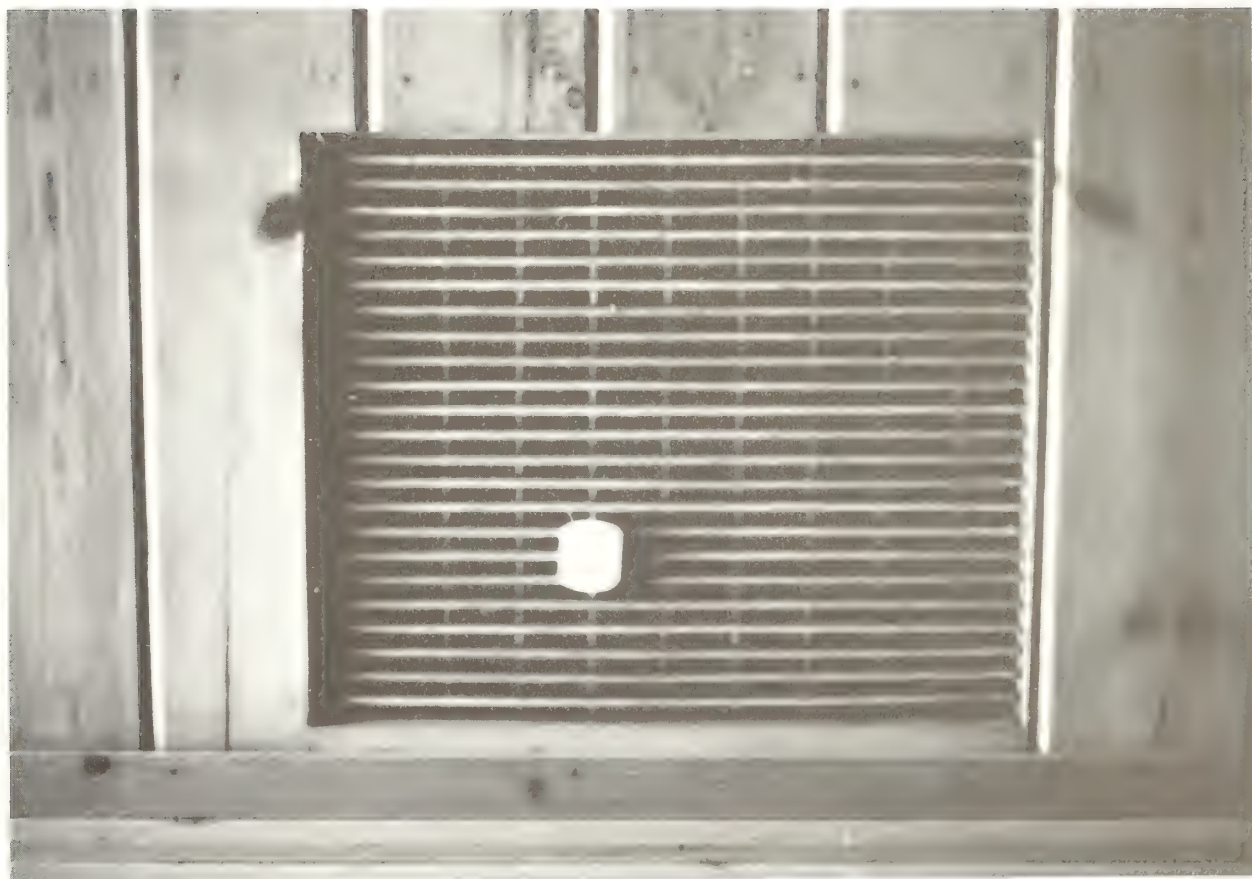
Figure D-8. Market--Ceiling Mounted Wooden Ventilation Grill (5/86).

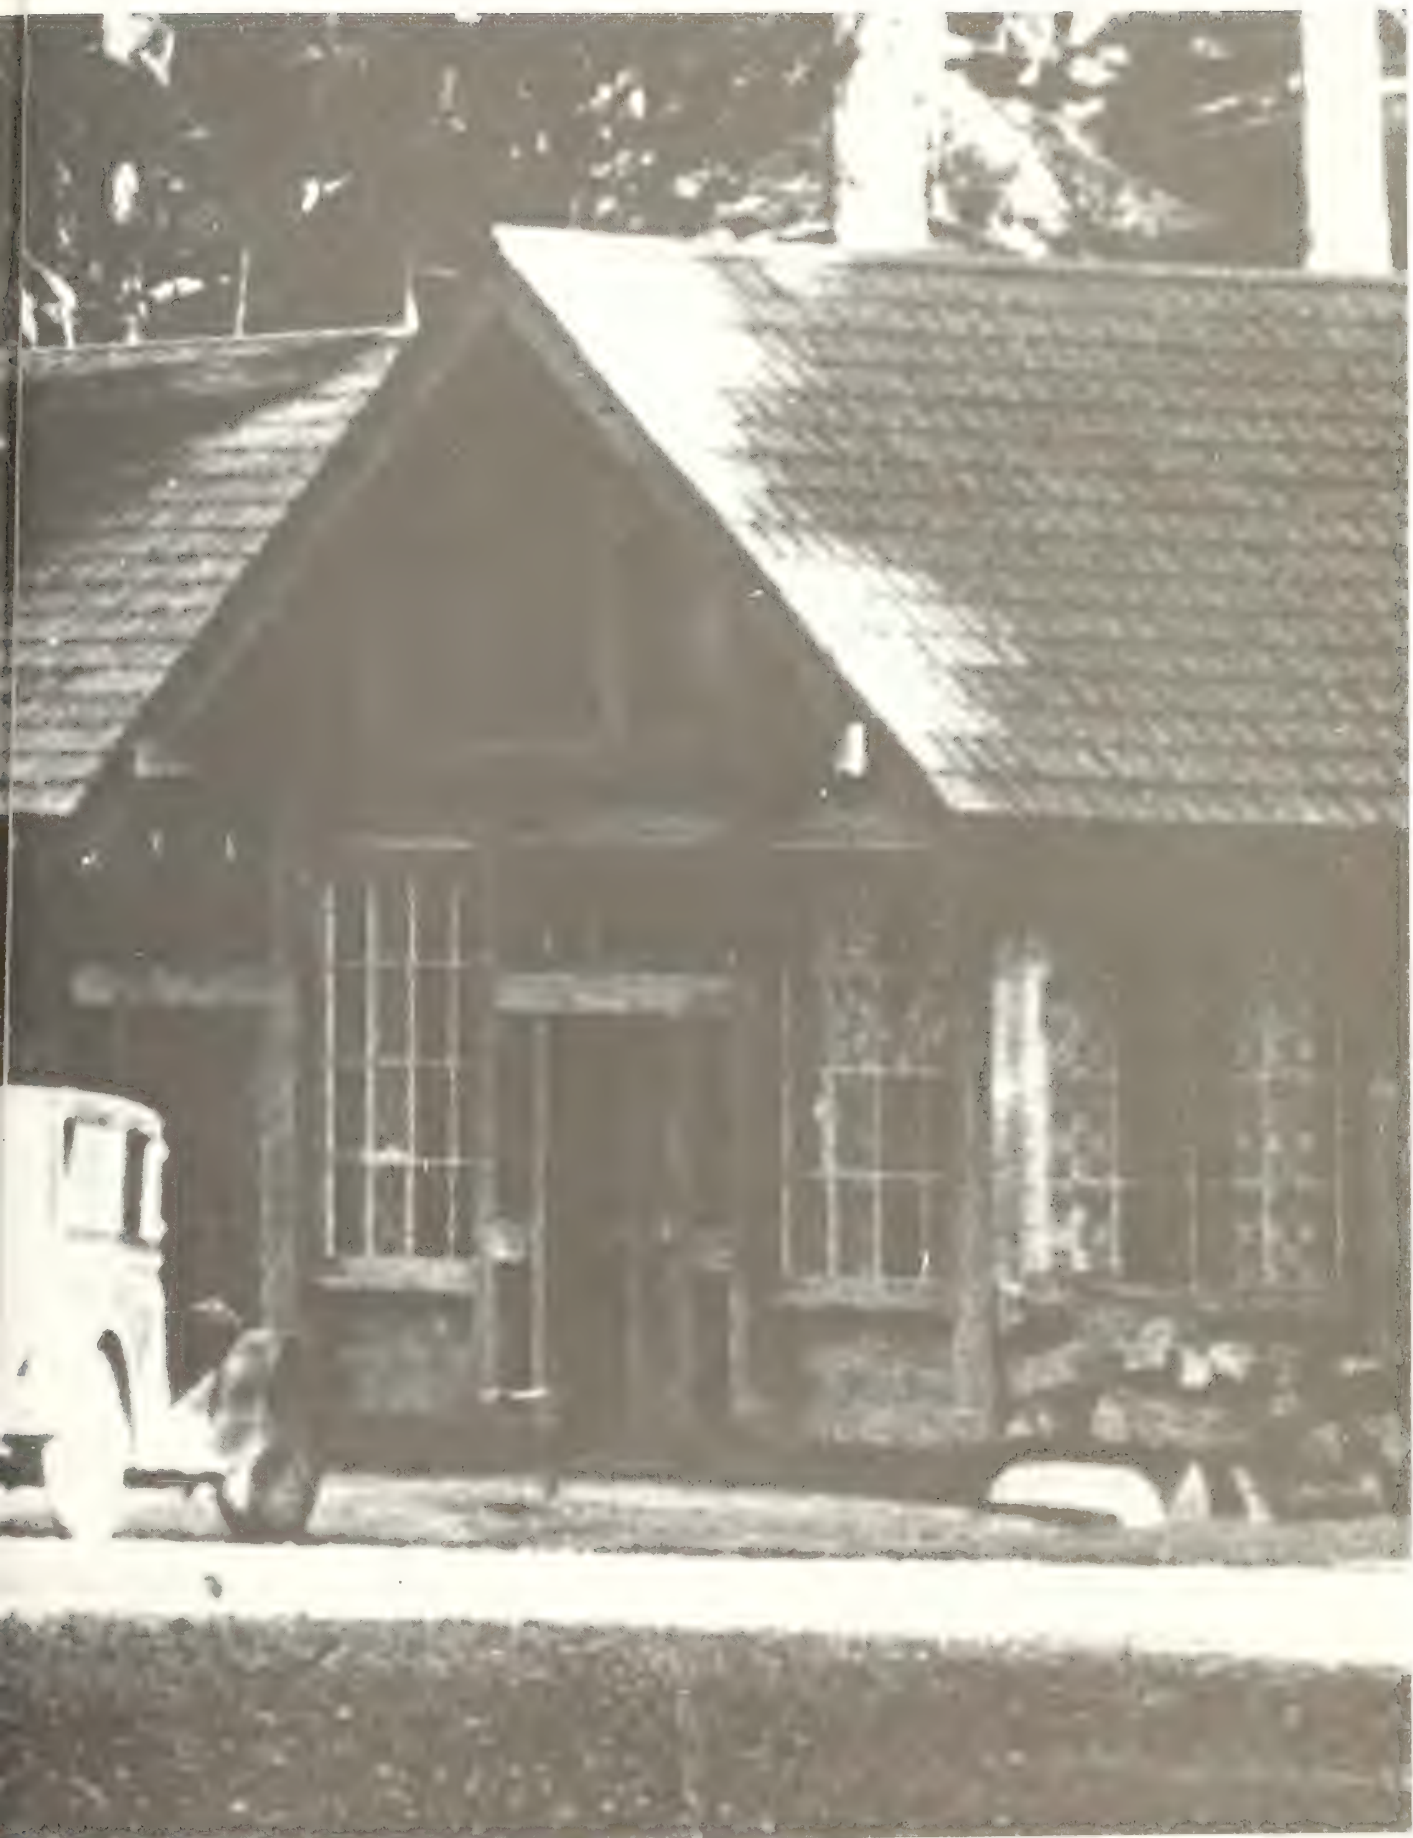
Figure H-1. South wing of Market (1932). This view is a blow-up of that portion of figure 16 which best illustrates the fenestration of the gable end of the south wing during the 1930s. (Photo by Lindley Eddy; SEQU archives #03153)

3. The preferred approach is to follow the "Secretary's Standards for Rehabilitation" (see Architectural Data, "Compliance with Regulations"). In this approach, as recommended in this HSR, treatments would restore the continuum of physical changes in the market through 1938--generally preserving its existing form--and would required a less destructive alteration than an attempt to return the building, or part of it, to a particular earlier appearance. This approach as stipulated in the "standards" would be characterized by:
